Biological Features

Water Resources

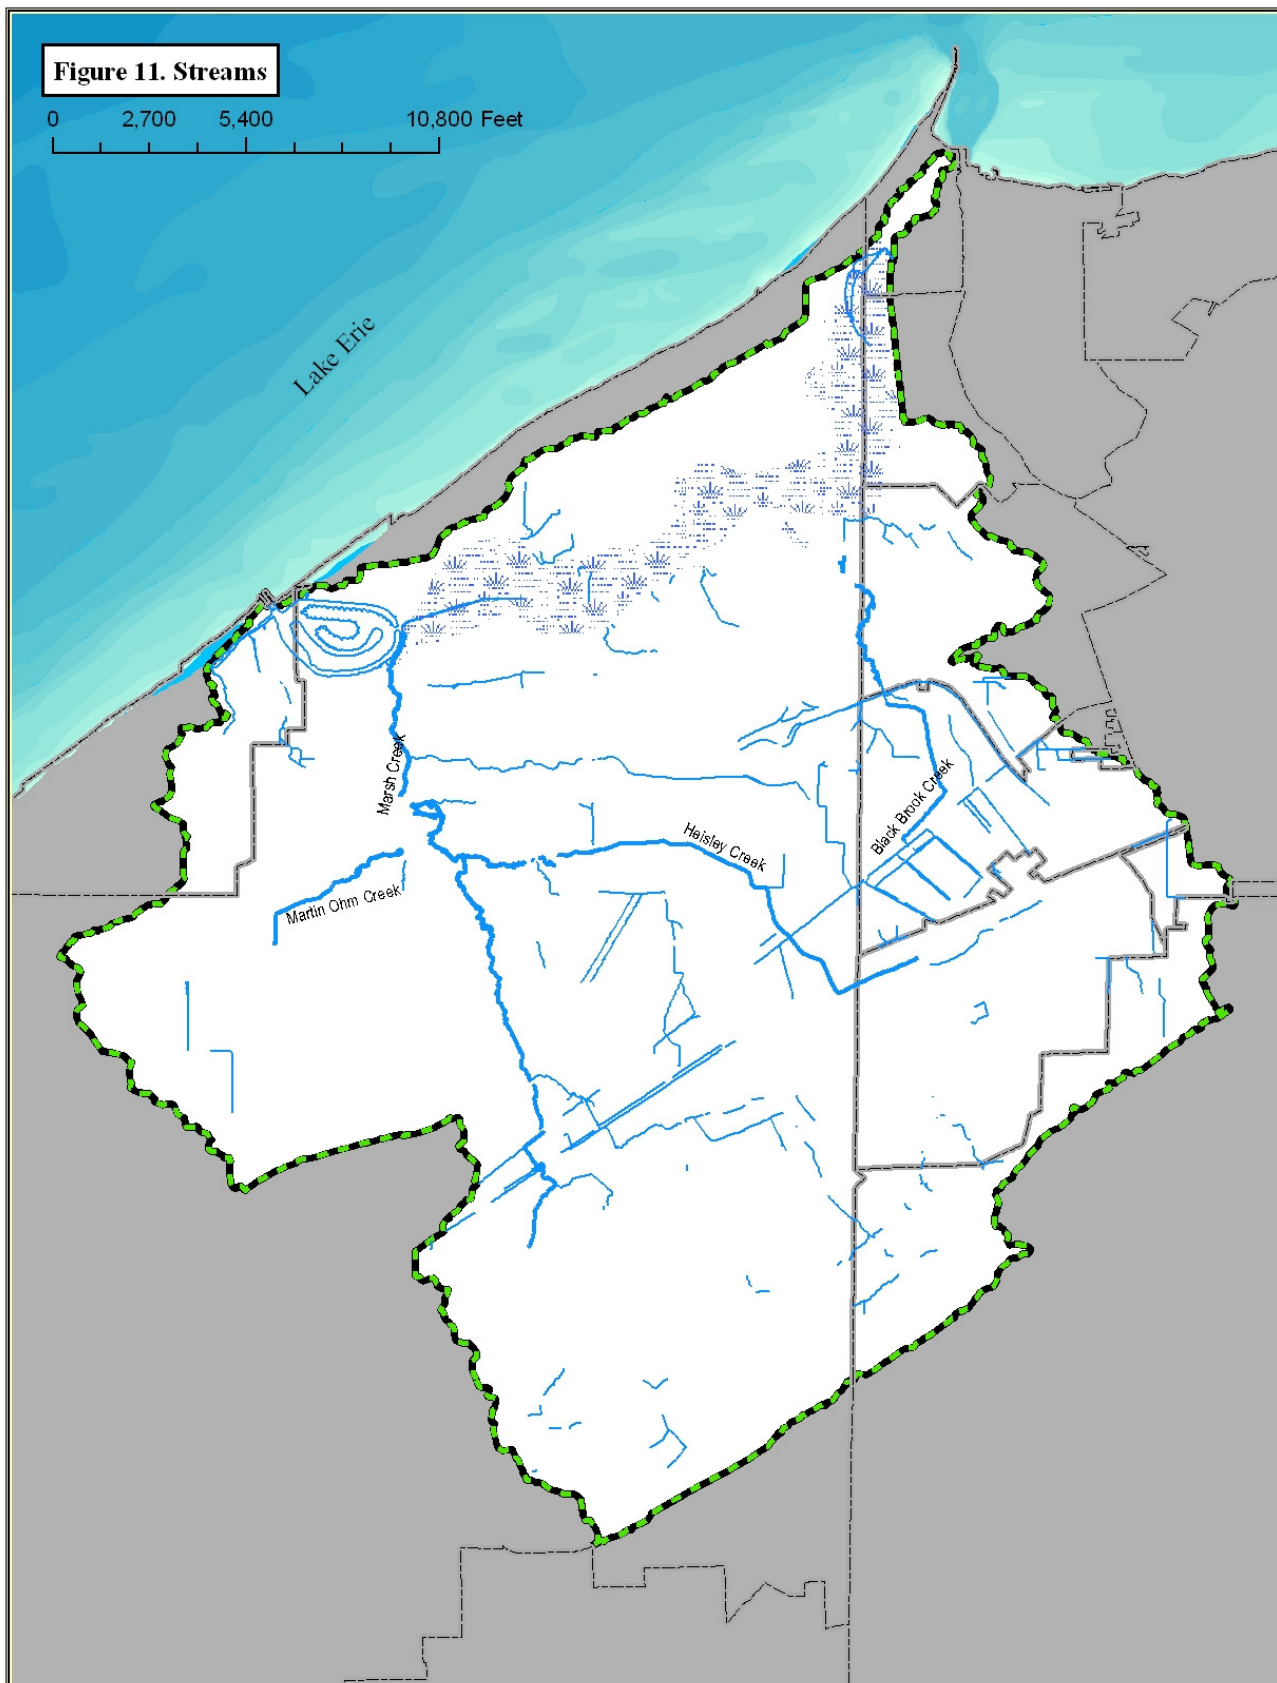
(included Mentor Headlands), and portions of Grand River, Painesville City, and Painesville Township. The landscape changes which started to occur in the late 1800's and continue today have resulted in a highly modified system of surface water drainage. Most of the functions of headwater stream systems in the watershed have been lost. A comparison of USGS topographic maps and USGS soil survey maps with current GIS hydrology layers show no wholesale system of culverts in the watershed. The exceptions are small sections of culverts for road crossings and a section of Blackbrook Creek near it's confluence with the marsh. The streams and surface water network are depicted in Figure 11. The subwatersheds are mapped in Figure 12. Figure 13 shows the extent of the 100-year floodplains.

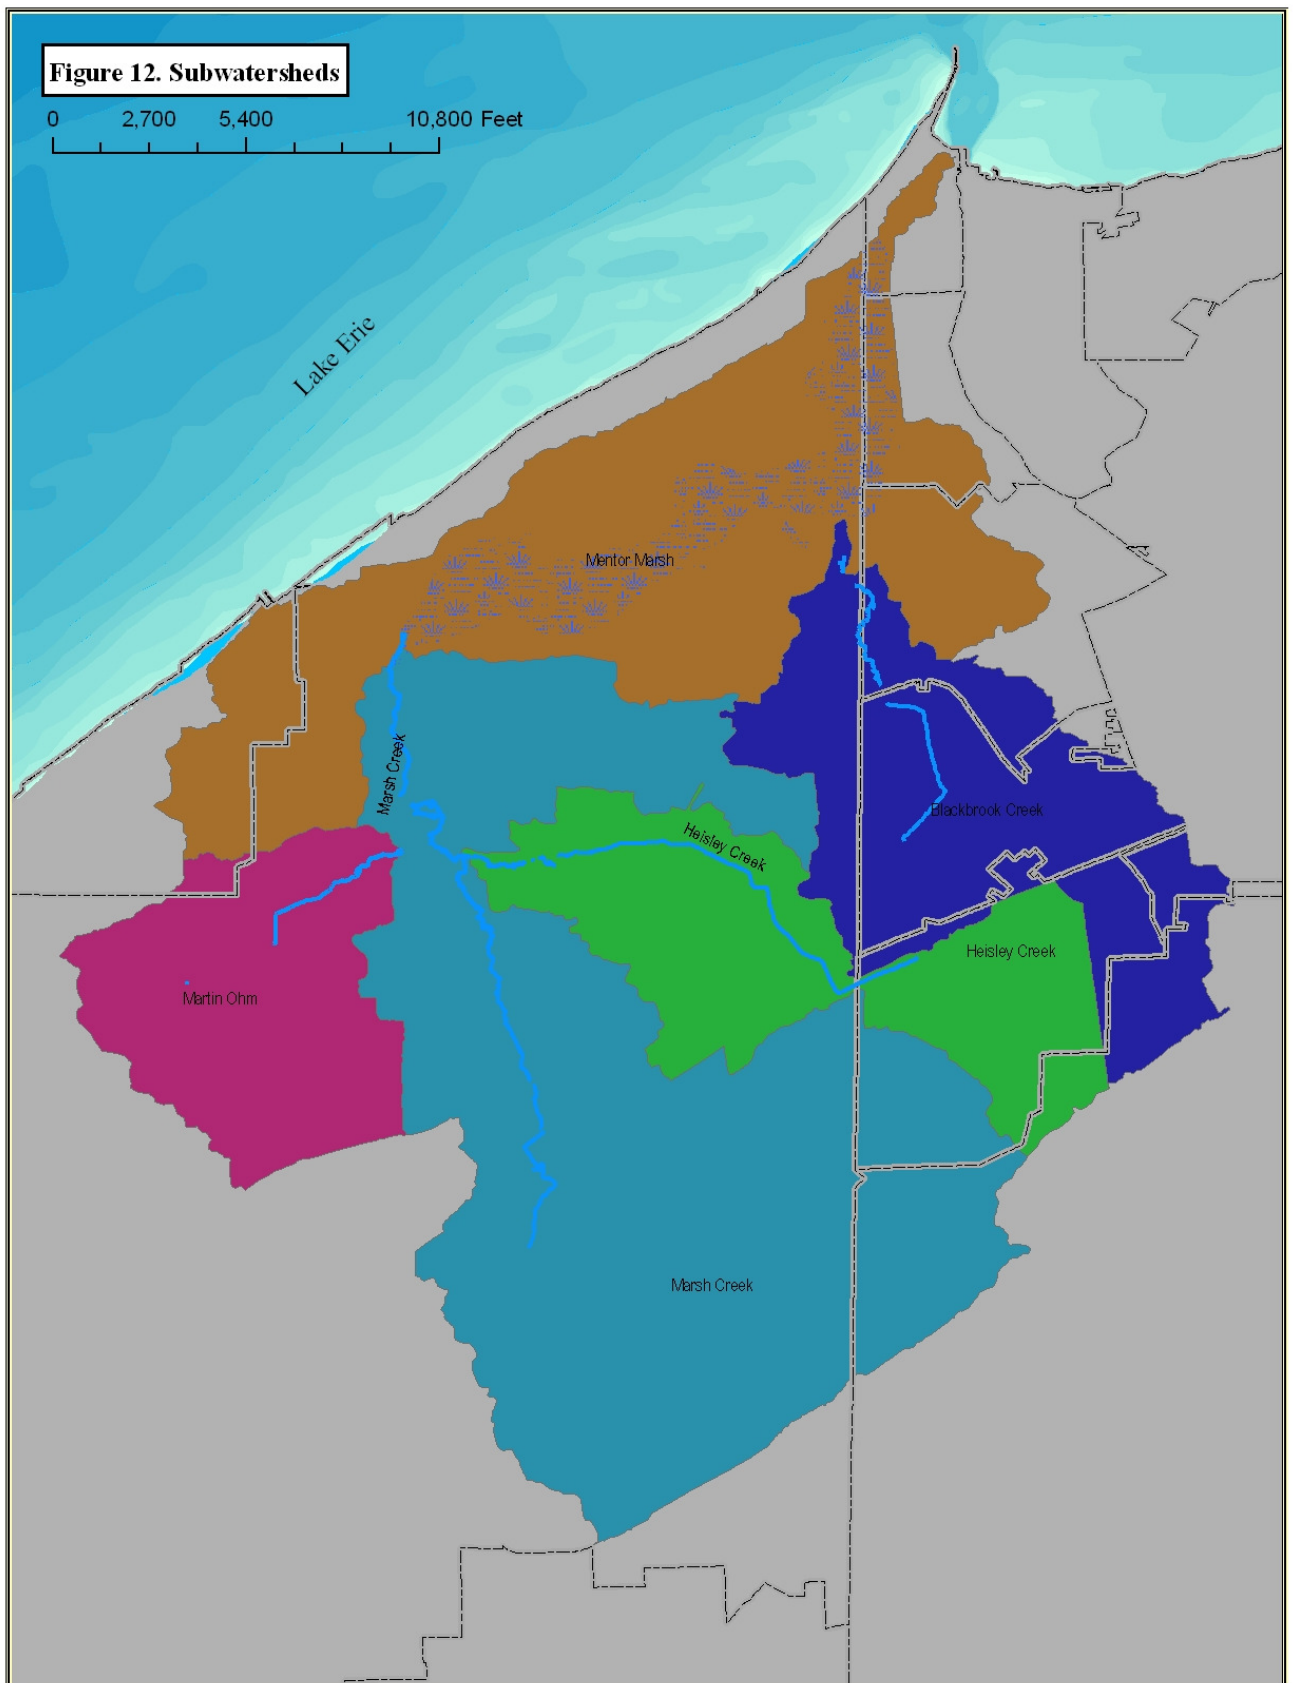
The Mentor Marsh Watershed drains 22.6 square miles, or 14463-acres. The watershed is divided into 3 sub-watersheds. The smallest is the Black Brook Creek watershed, which drains 2128.11-acres. Black Brook Creek drains from northwest Concord Township into Painesville Township and then into Painesville City before entering the City of Mentor near it’s confluence with the Mentor Marsh. The confluence is on the eastern end of the marsh near State Route 44 and Deer Ridge Road. No 100-year floodplain has been officially mapped in this subwatershed. The largest subwatershed is Marsh Creek, which drains 8859.26-acres. Marsh Creek also starts in northwest Concord Township and then drains into the City of Mentor and confluences with the marsh near Mentor Lagoons. An extensive 100-year floodplain exists along Marsh Creek, extending as far south as Jackson Street. Floodplains mapped by FEMA are also located along a large unnamed tributary to Marsh Creek that flows along Hilltop Drive and extends into the headwaters along the active CSX railroad north of Jackson Street.

Marsh Creek has two large tributaries, Heisley Creek and Martin Ohm Creek. The Heisley Creek Watershed is 1766.9-acres and starts in northwest Concord Township. It then flows into Painesville Township before entering the City of Mentor where it enters Marsh Creek near Harvest Home Drive and Walden Court. Heisley Creek also contains extensive FEMA floodplains from it’s confluence with Marsh Creek to the Painesville Township line. The floodplain becomes very wide south of the CSX railroad. Most likely due to inadequate culvert capacity backing up floodwaters along drainage ditches parallel to the railroad.

The Martin Ohm Creek Watershed is 1459.25-acres and aside from a small portion of the watershed located in southeast Mentor-on-the-Lake; the entire watershed is located in the City of Mentor. Martin Ohm Creek is the only surface water tributary to the marsh in the western limits of the watershed, no FEMA floodplains were identified along the creek.

The last of the subwatersheds is the Mentor Marsh Watershed, which drains 3473.70-acres (excluding the Marsh Creek and Black Brook Creek tributaries). This watershed is typified by overland flow and stormwater inputs from culverts and highly modified surface water channels. The watershed drains eastern Mentor-on-the-Lake, the northern portion of the City of Mentor
